Quarry with a gas problem

Georgia Malin BSc FGS

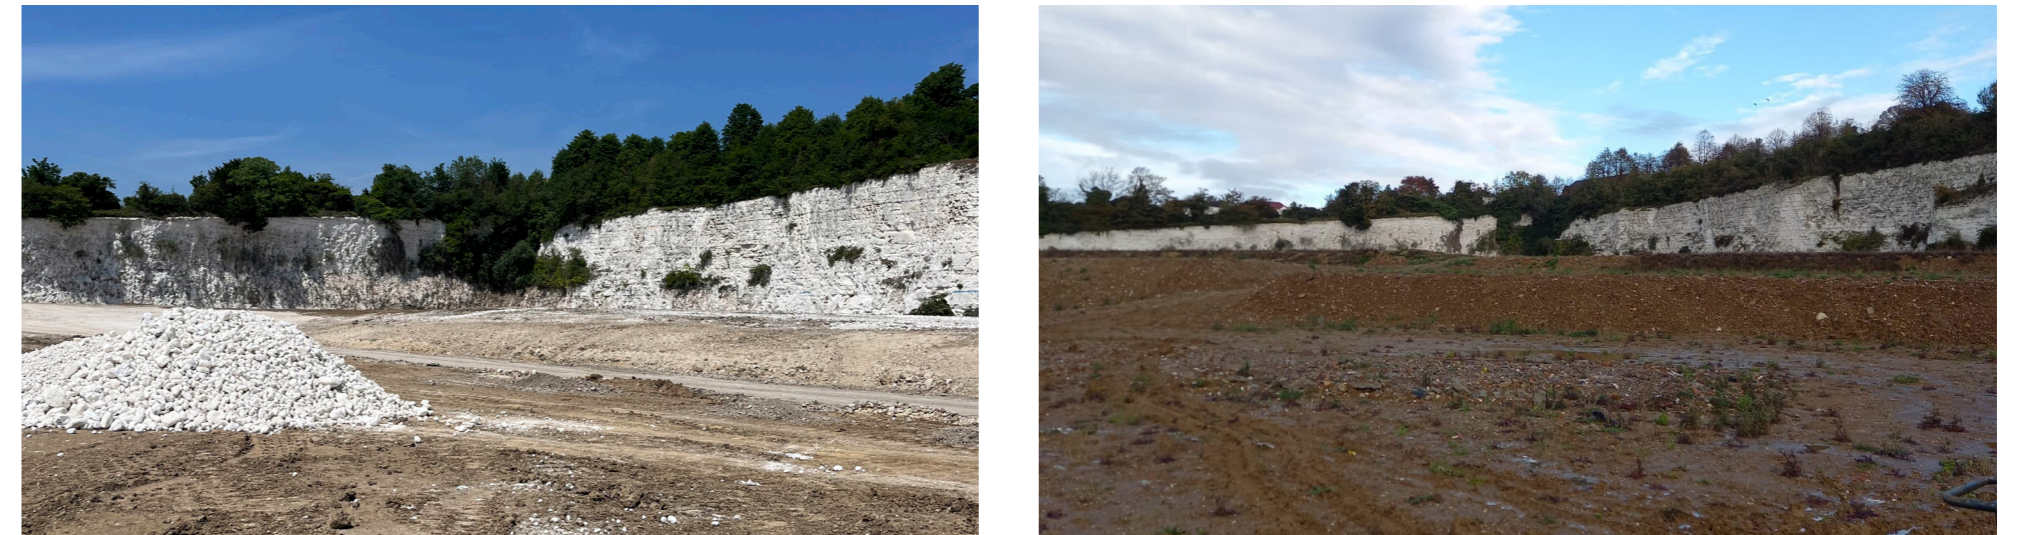
View of site while filling operations were underway (left), and view of completed operations (right).

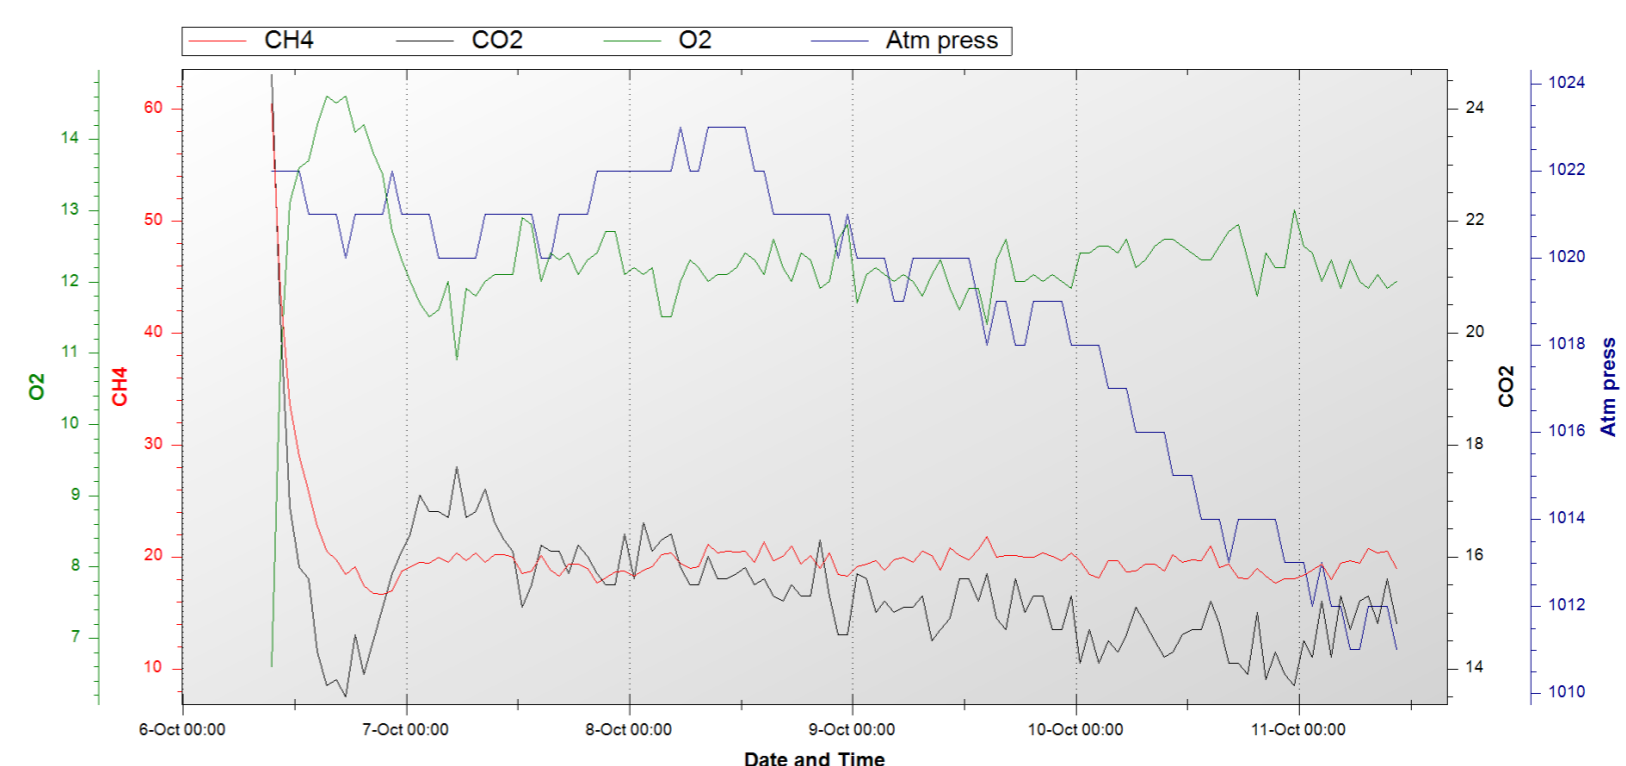
*Graph representing continuous gas monitoring in one borehole

Continuous gas monitoring recorded methane concentrations of up to 60% before decreasing to a consistent reading of between 20 and 25%. Carbon dioxide concentrations spiked at around 24% before dropping to between 14 and 18% for the remainder of the monitoring. While these were the worst concentrations recorded on-site, the other four boreholes recorded elevated levels of both methane and carbon dioxide consistently.

On two occasions, flow was recorded at low and falling atmospheric pressure, which revealed that both methane and carbon dioxide levels were also decreasing.

It is considered likely that the gas levels recorded were generated from the breakdown of organic material entrained within the imported inert material and voids created through insufficient compaction during deposition.

To enable efficient development of the site, it was recommended that at least six months of continuous gas monitoring (inclusive of flow) be undertaken to capture the worst case scenario and to inform gas protection measures or further monitoring or assessment. This would be supplemented with further intrusive investigation to delineate the extent of existing soft zones or voids and to enable testing of imported material for organic content.
